# Manhole Inspection Summary

Manhole # S35CC1014MH

Insp Date: **12/7/06 8:50 AM**

**Location** Address: **3513 CALVERT ST**

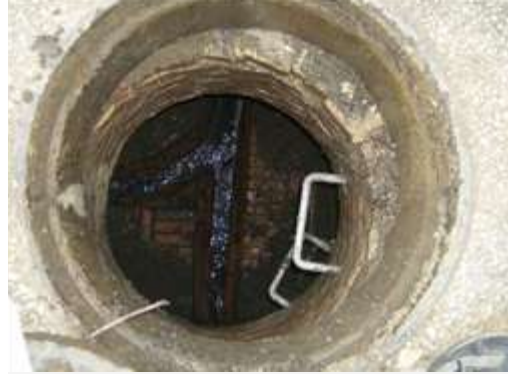
Top View

Evidence of surcharge - Bench debris.

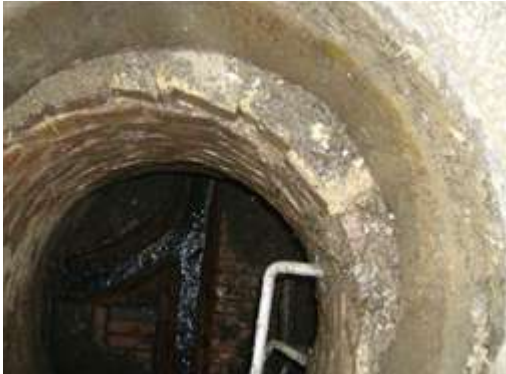
Defect

Frame leaks. Frame offset. Adjustment deterioration and infiltration. Corbel infiltration.

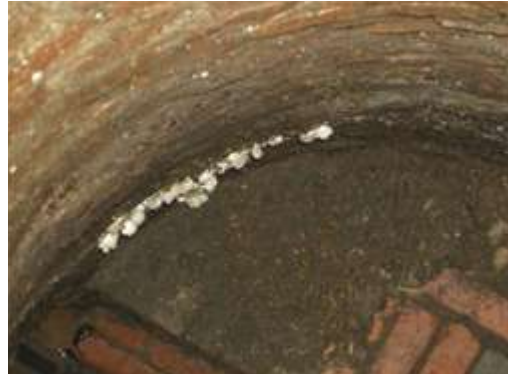
Defect

Evidence of surcharge - Bench debris.

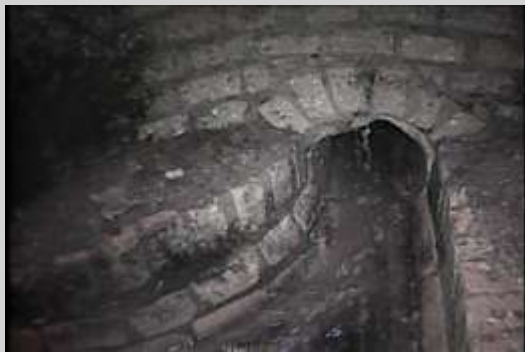
### 8 in. Circular Gravity Sewer Pipe Out @ 12 O'Clock

Infiltration: **Evidence** Pipe Seal Cond: **Unknown**
